LER 2000-004
Davis-Besse Nuclear Power Station, Unit No. 1
Date of Occurrence - April 22, 2000

FACILITY NAME (1) Davis-Besse Unit Number 1						DOCKET NUMBER (2) 05000346		PAGE (3) 1 OF 6							
TITLE (4) Personnel Error During Bus Transfer Testing Results In Loss of Offsite Power															
EVENT DATE (5)			LER NUMBER (6)			REPORT DATE (7)			OTHER FACILITIES INVOLVED (8)						
MONTH	DAY	YEAR	YEAR	SEQUENTIAL NUMBER	REVISION NUMBER	MONTH	DAY	YEAR	FACILITY NAME	DOCKET NUMBER					
04	22	2000	2000	-- 004 --	00	05	20	2000	FACILITY NAME	DOCKET NUMBER					
										05000					
										05000					
OPERATING MODE (9)		D		THIS REPORT IS SUBMITTED PURSUANT TO THE REQUIREMENTS OF 10 CFR §: (Check one or more) (11)											
POWER LEVEL (10)		000		20.2201(b)		20.2203(a)(2)(v)		50.73(a)(2)(i)		50.73(a)(2)(viii)

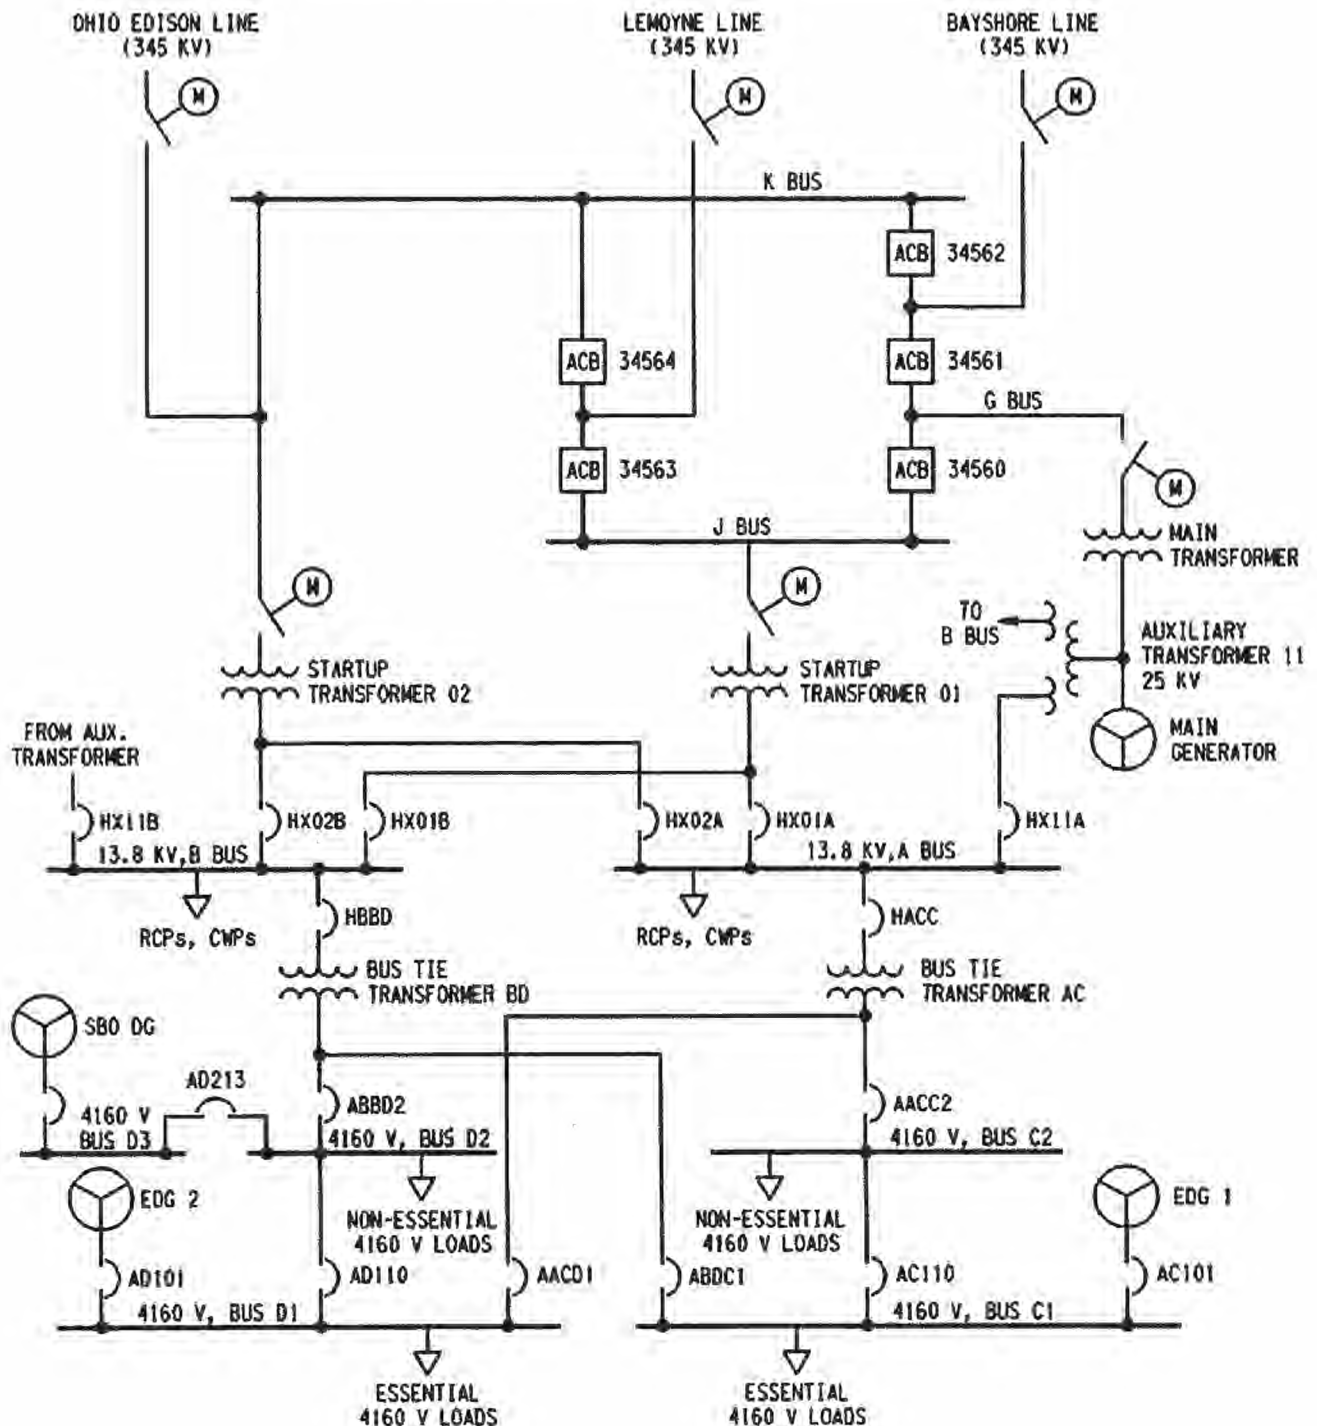
FIGURE 1-DAVIS-BESSE ELECTRICAL DISTRIBUTION SYSTEM

Davis-Besse Nuclear Power Station (DBNPS) Technical Specification Surveillance Requirement 4.8.1.1.1.b states that each qualified circuit between the offsite transmission network and the onsite Class 1E A.C. electrical power distribution system be demonstrated operable at least once each refueling interval during shutdown by manually and automatically transferring unit power supply to each of the offsite circuits. On April 22, 2000, during the twelfth refueling outage with the reactor defueled, Surveillance Test DB-SC-03022, Off-Site AC Sources Bus Transfer Test, was initiated to fulfill this Surveillance Requirement. All station loads were being powered from the 345 kV Bayshore line [FK] through Startup Transformer 01 [EA-XFMR] and 13.8 kV bus A [EA-BU] in accordance with this test to allow testing to be conducted on 13.8 kV bus B. Refer to Figure 1 for a diagram of the DBNPS electrical system.

With switchyard breaker 34563 [FK-BRKR] open, an automatic (fast dead) transfer of Bus B from Startup Transformer 02 to Startup Transformer 01 was performed by simulating a fault on Startup Transformer 02. Breaker HX02B [EA-BRKR] tripped isolating Bus B from Startup Transformer 02, and breaker HX01B closed to power Bus B from Startup Transformer 01. Switchyard breakers 34562 and 34564 and Ohio Edison breakers B-88 and B-115 at the Beaver Substation opened to isolate Startup Transformer 02 from the 345kV distribution system. All associated equipment performed as expected. Annunciator alarm 1-1-G, Startup Transformer 02 Lockout, was also illuminated as expected in the control room.

The actuation of the main generator protection relay 74-B/GX(XK) at 2340 hours on April 22, 2000, caused a lockout of the main generator [EL-TG] and main transformer [EL-XFMR], opening switchyard breakers 34560 and 34561. This interrupted the circuit between the Bayshore line and Startup Transformer 01, resulting in a loss of offsite power. Both emergency diesel generators [EK-DG] started and loaded onto their respective essential buses. The loss of offsite power resulted in a loss of flow in the spent fuel pool cooling system [DA] since the spent fuel pool cooling system is not powered from an essential electrical bus (the reactor core was off-loaded to the spent fuel pool at the time). Station and instrument air alarms were also received due to the loss of electrical power to the air compressors.
